NASA CR-188258

Final Report

THE MAGNITUDE OF IMPACT DAMAGE ON LDEF MATERIALS

Martha Allbrooks and Dale Atkinson  
POD Associates, Inc.  
2309 Renard Place, S.E.  
Suite 201  
Albuquerque, New Mexico 87106

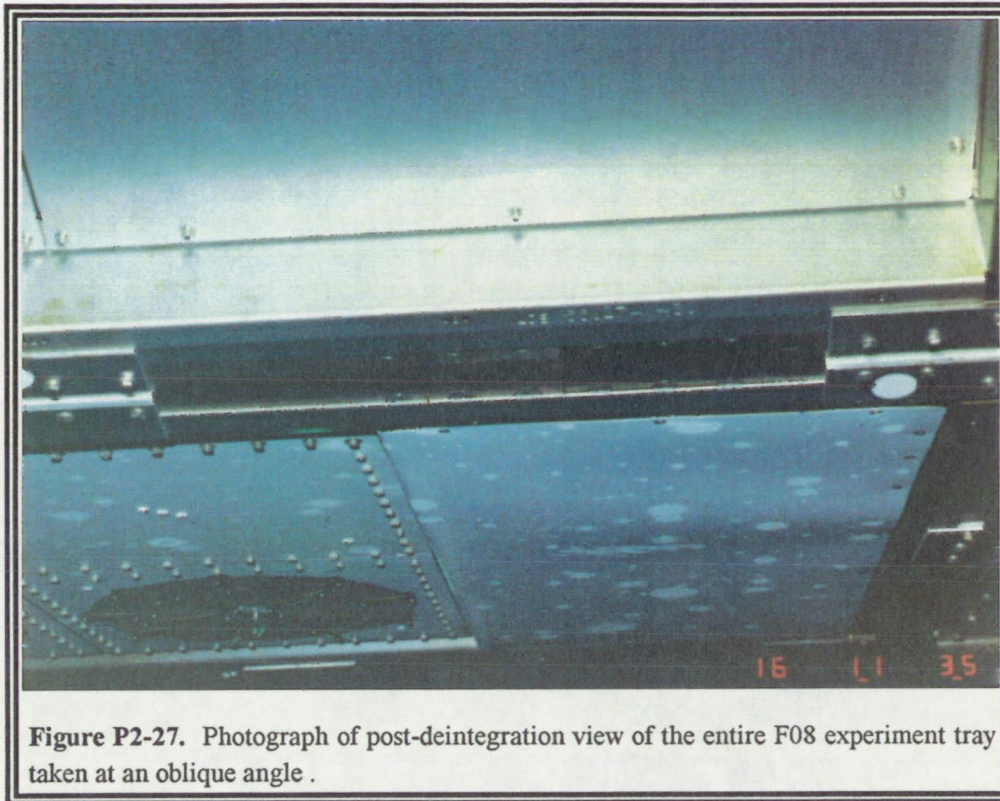
**Figure P2-27 (S90-43421)** is a picture of the overall M0004 experiment tray (Bay F08). This picture was taken with an oblique view to show the extent of the damaged areas on the white thermal control paint (Chemglaze A276). This paint has been exposed to AO thus removing the upper layer of binder and leaving behind a thin layer of loosely attached pigment particles. LDEF's thermal control paints showed several very interesting types of impact-related phenomena and provided the first examples of the ring phenomena. The ring phenomena occurs in many different varieties. **Figure P2-28 (KSC-390C-1937.6)** shows one type of ring morphology which was rarer than the others. This figure shows multiple craters (on the same surface shown in Figure P2-27) where the rings appear to be caused by the very top layer of paint being wrinkled and rolled back. This total view measures ~8cm across. **Figure P2-29 (KSC-390C-1937.7)** is a closer look at one of these craters. This figure shows a central crater surrounded by a spallation area and a cleared smooth area, which is then surrounded by the upraised rings. The rings look as though the top layer of paint has been rolled or folded back over the surface by a surface shock wave.

**Figure P2-27.** Photograph of post-deintegration view of the entire F08 experiment tray taken at an oblique angle .

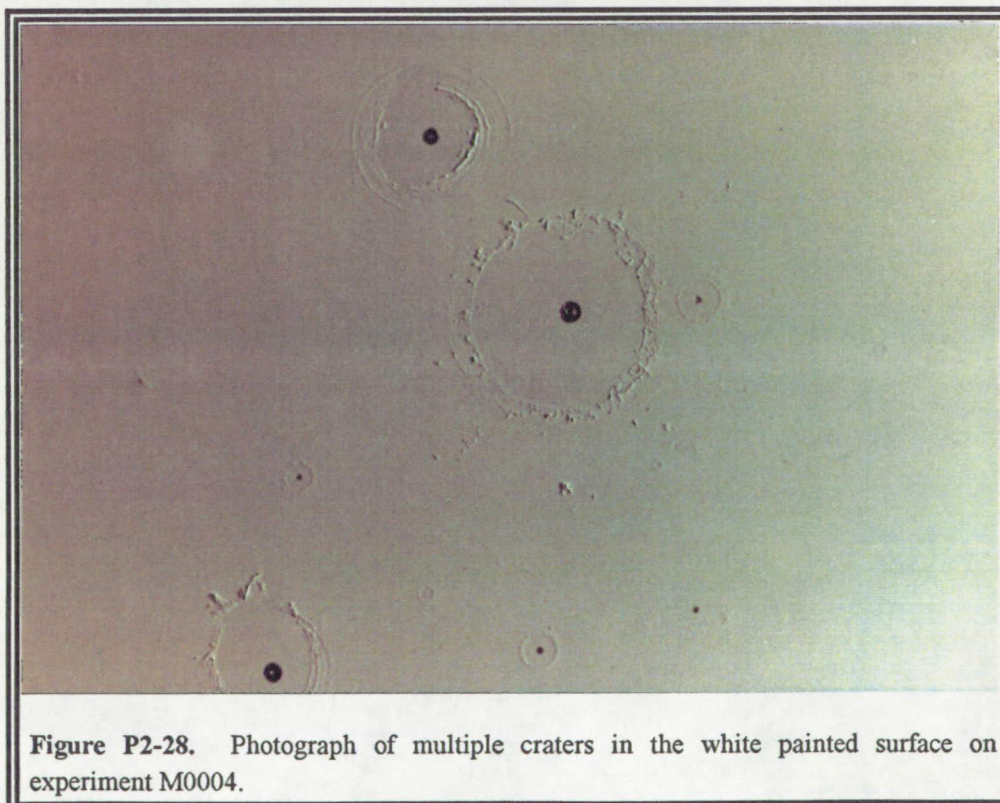
**Figure P2-28.** Photograph of multiple craters in the white painted surface on experiment M0004.

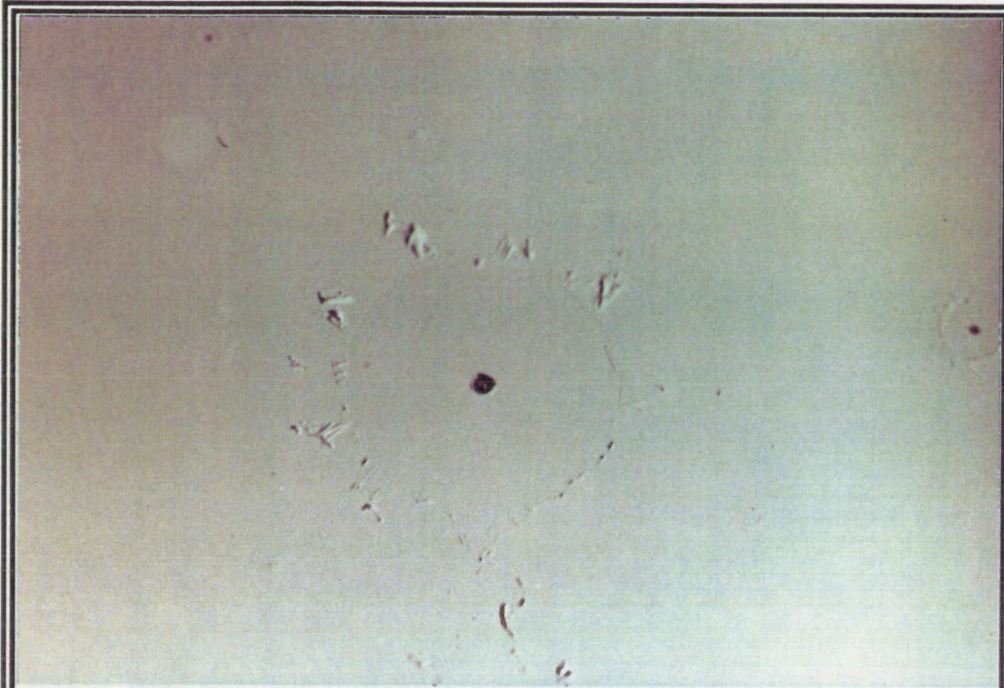
**Figure P2-29.** Photograph of an impact feature in the white painted surface on experiment M0004.

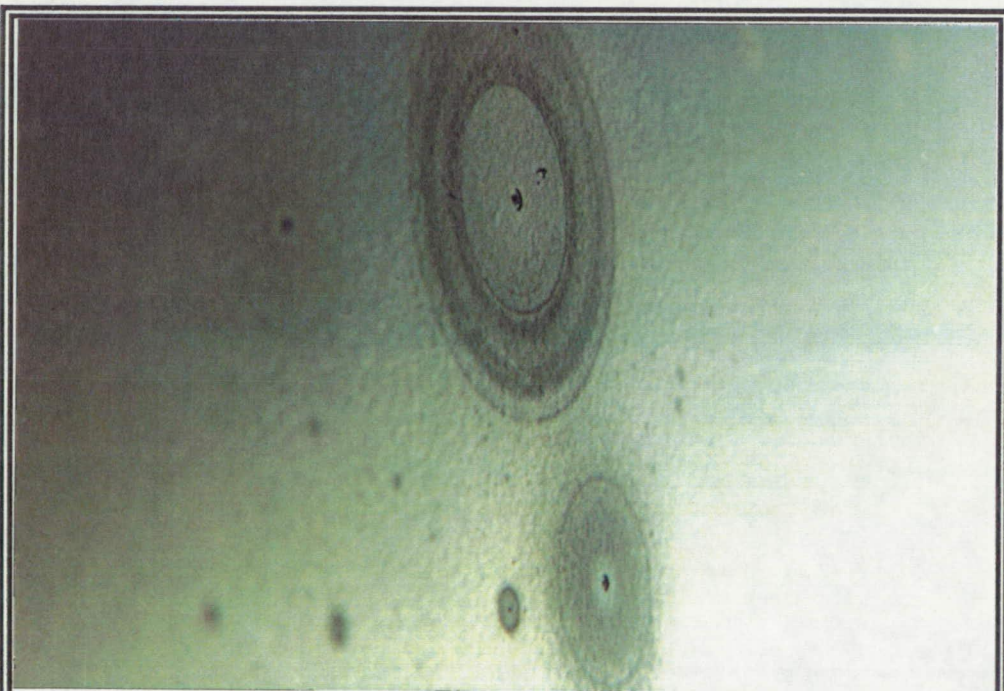
**Figure P2-30 (KSC-390C-1938.1)** shows the more dominant type of ring features seen in the thermal control paints. In these features, craters were typically surrounded by an area of paint spalled from the front surface. This spallation area is surrounded by a smooth area, with little or no visible damage, which is surrounded by a series of rings. These rings are upraised areas of dislodged paint or pigment powder on the surface of the paint substrate.

**Figure P2-30.** Photograph of an impact feature in a white painted surface showing ring features.

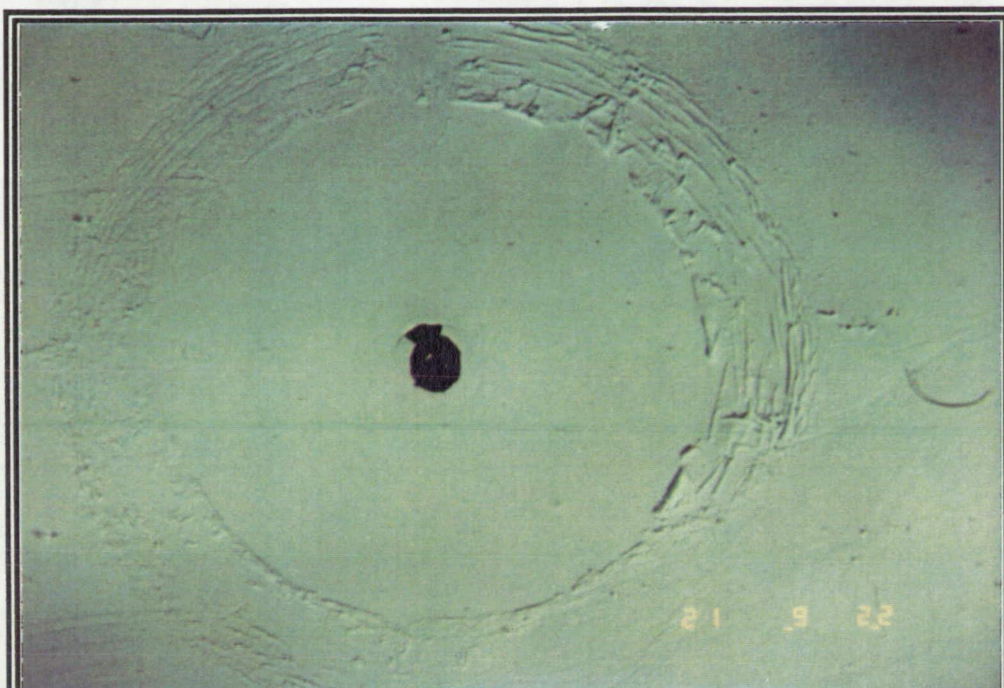
**Figure P2-31a (POD-9014-001)** is a picture of one of these ring features showing the central crater with its upraised lips in the aluminum substrate, and a surrounding area of spallation with a small area of uplifted paint which did not have enough energy to spall. This area is then surrounded by an area of no damage or particulates, followed by an extensive ring structure. On the left some of these rings look like merely raises in the powder, whereas on the upper right side the rings look as if the upper surface of paint folded back. **Figure P2-31b (POD-9014-002)** is a higher magnification view of this same ring structure and shows a close up of the folds described above. These folds appear to be a thin layer of rolled up or peeled back paint.

**Figure P2-31a.** Photograph of an impact feature in a white painted surface showing ring features.

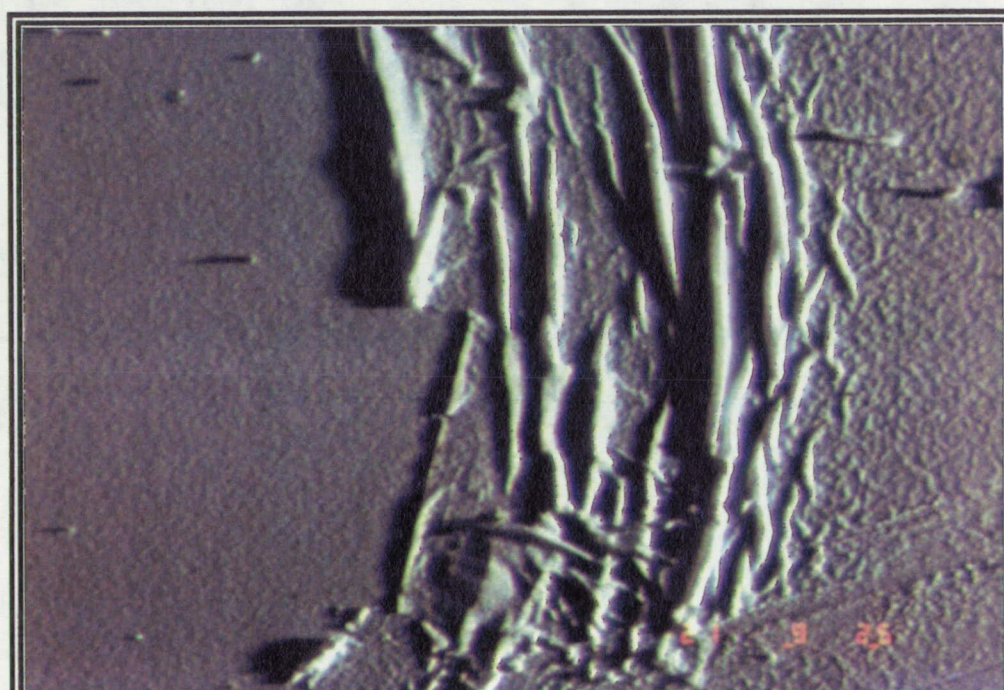
**Figure P2-31b.** Photograph of the same impact as Figure P2-31a at a higher magnification showing ring features.

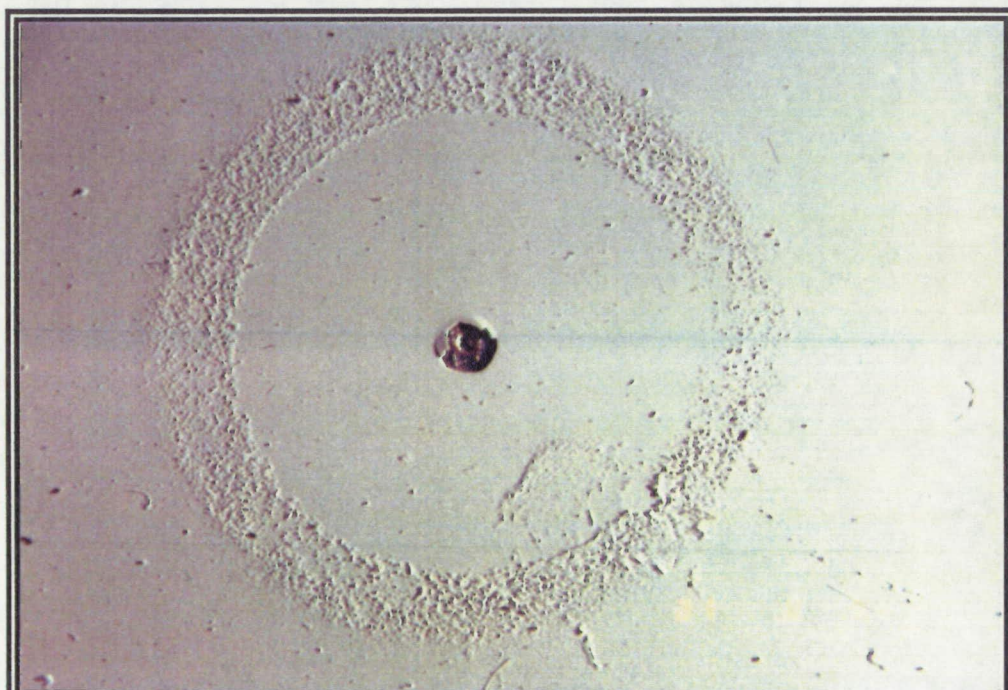
**Figure P2-33.** Photograph of an impact feature in a white painted surface showing ring features.

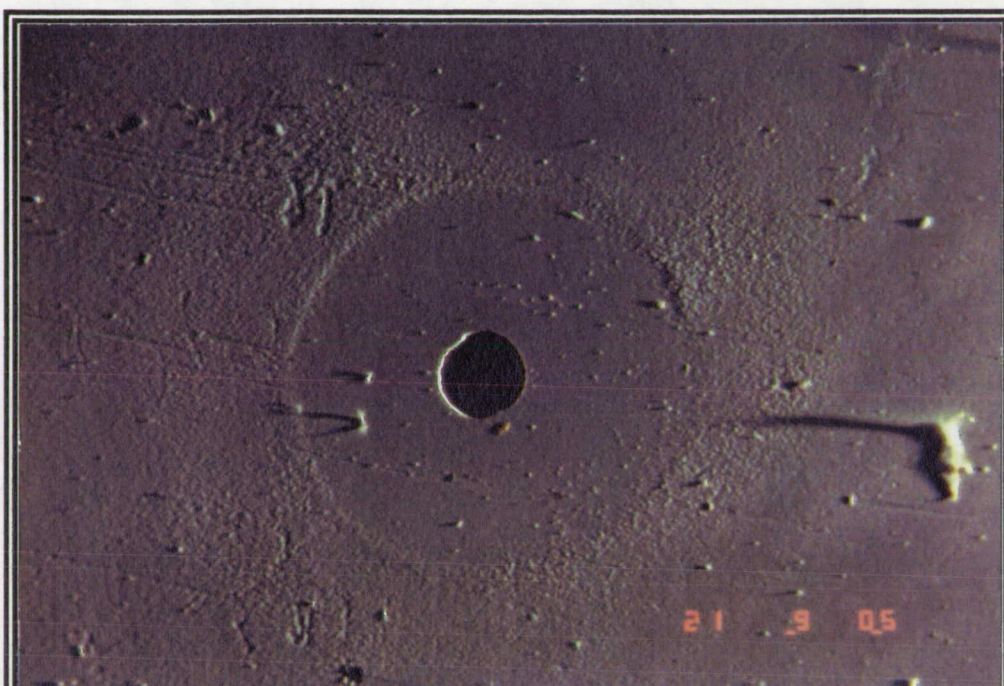
**Figure P2-34 (POD-9014-005)** shows the last crater in this sequence. Again the morphology is similar in that there is a central crater in the aluminum substrate, a large spallation area where the paint was removed, an area where most of the paint pigment has been removed, and then an outer area of rings. These rings have been almost totally eroded by AO, or alternately, the outer rings may be surface shock phenomena in very aged paints where there is very little binder left and

**Figure P2-34.** Photograph of an impact feature in a white painted surface showing ring features.

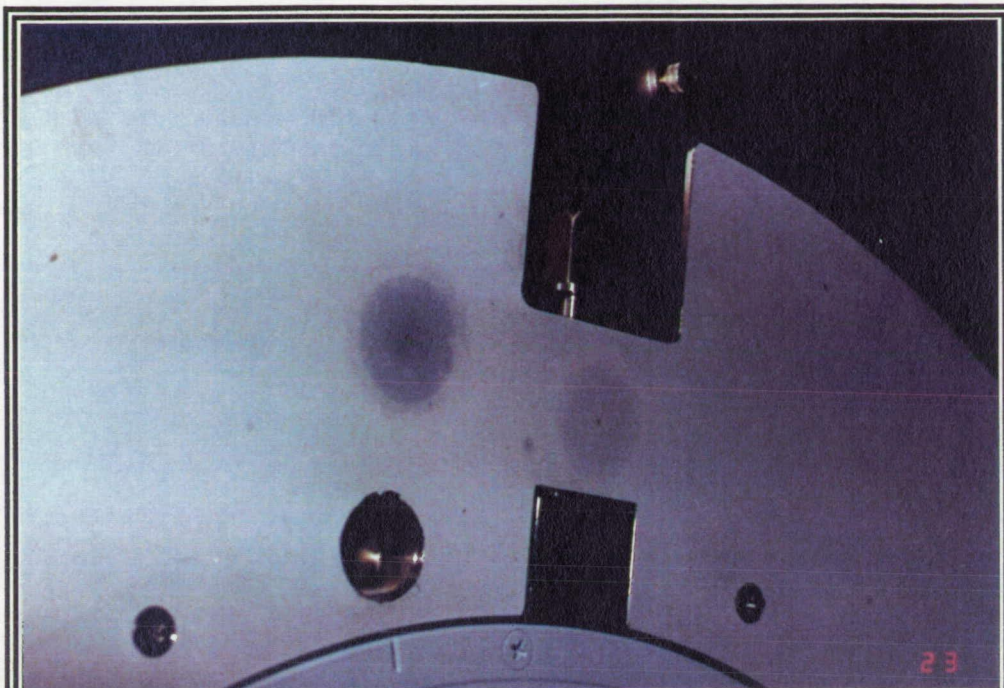
**Figure P2-35 (S90-43597)** is a picture of a crater in the gray thermal control paint on the active grapple fixture from LDEF Bay C10. This picture shows several different impacts with surrounding ring structures in the paint. **Figure P2-36 (KSC-390C-1937.2)** is an excellent example of the rings in this grapple plate. This picture shows a central crater in the underlying aluminum substrate surrounded by a spallation zone, an outer spallation zone where only the upper layer of paint was removed, and upraised rings on the outer surface.

**Figure P2-35.** Photograph of an impact feature in the painted aluminum surface from the Grapple plate on tray C10.

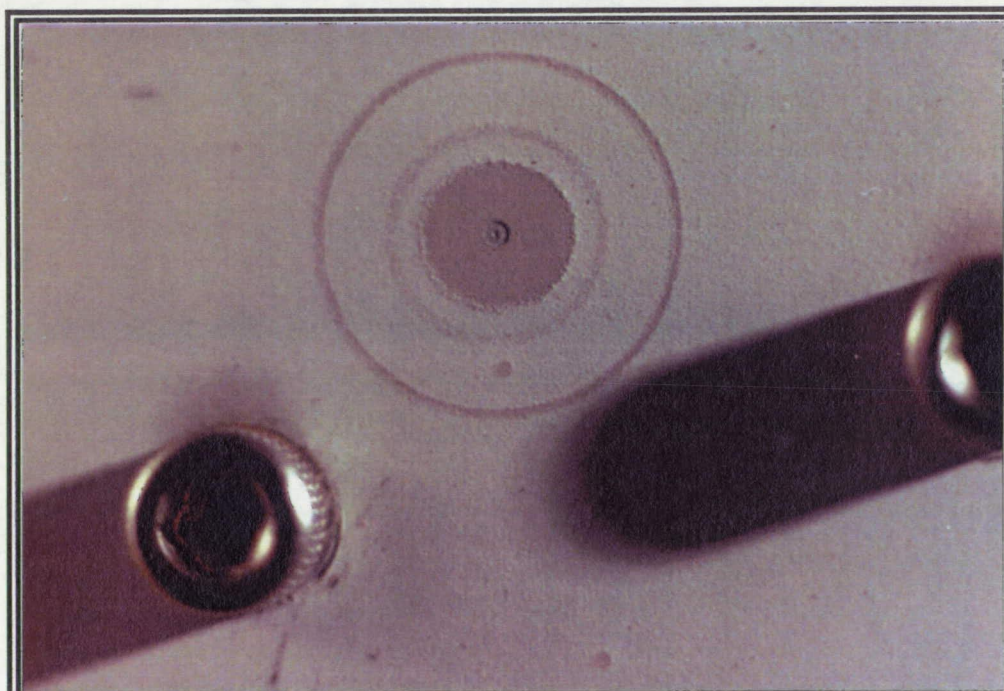
**Figure P2-36.** Photograph of an impact feature in the painted surface from the Grapple plate on tray C10 showing ring features.

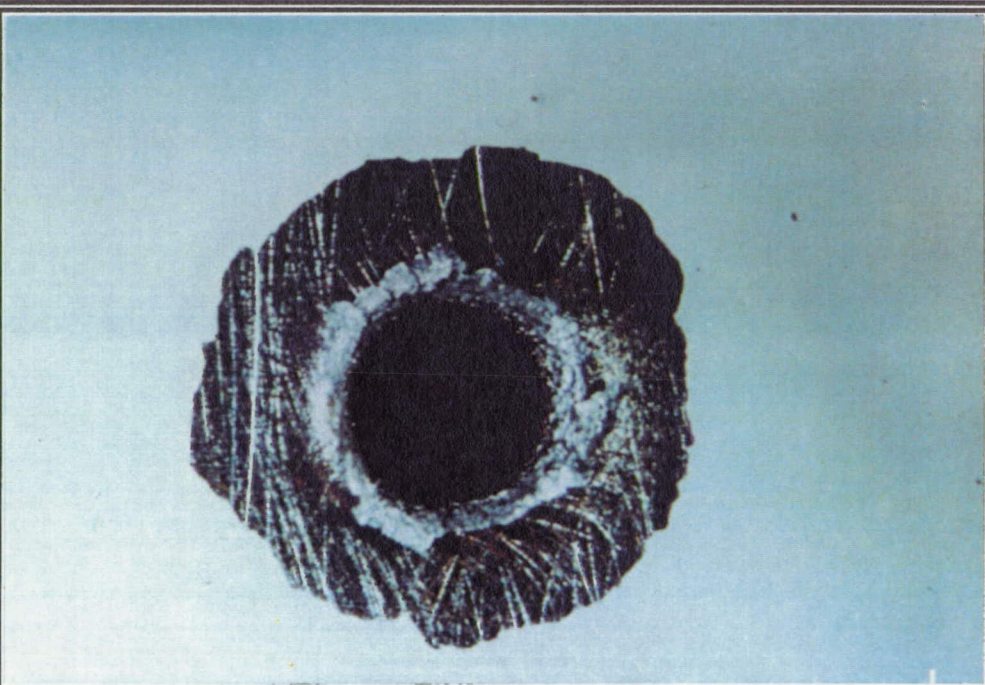
**Figure P2-38 (S90-44961)** shows a penetration through a white painted aluminum surface from the trailing edge. The penetration hole is typical of hypervelocity penetrations through aluminum. The penetration has large well-formed lips on the front surface in the aluminum and a large

**Figure P2-38.** Photograph of an impact penetration through a white painted aluminum surface from the trailing edge.

spallation area around this surface. Note again that no ring structures were formed. The back surface of this penetration was shown in Section 2.1 as Figure P2-2.

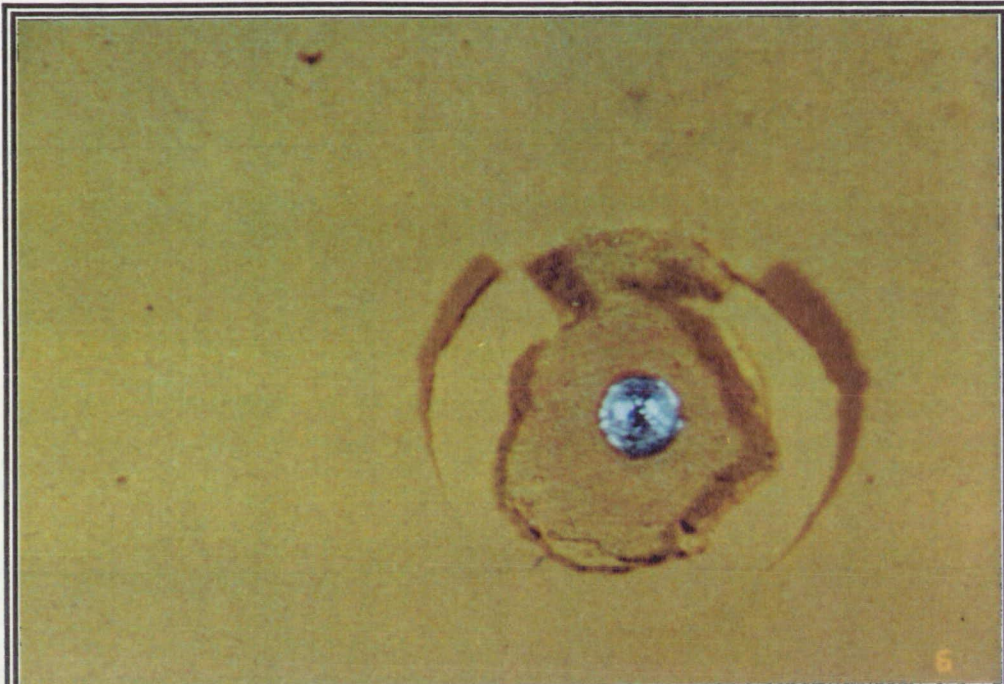
**Figure P2-39a.** Photograph of an impact feature in a yellow painted aluminum scuff plate from the trailing edge.

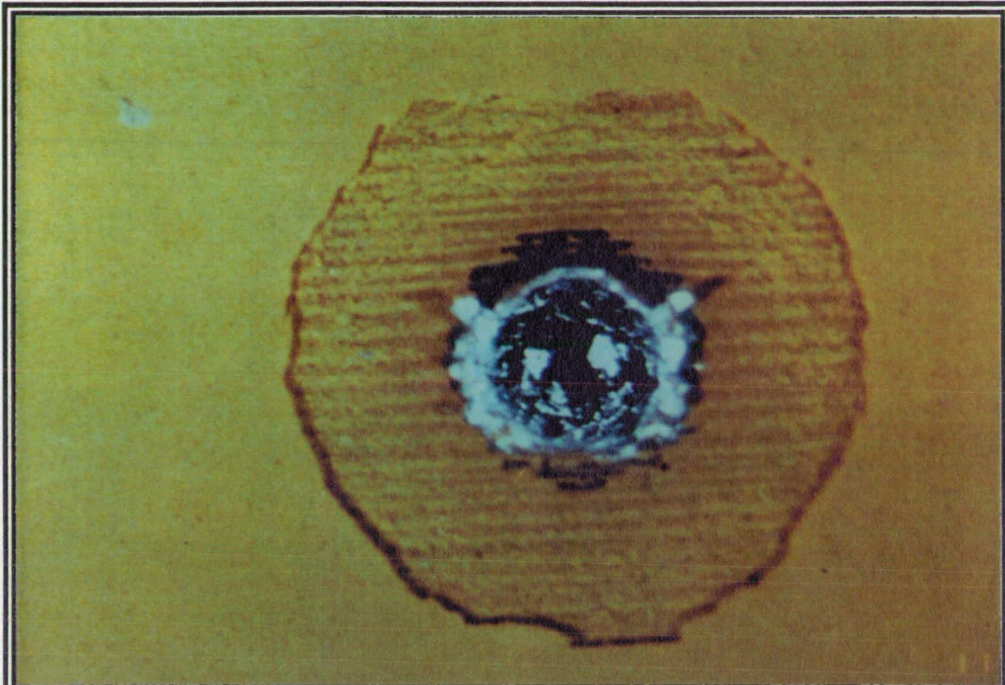
**Figure P2-39c.** Photograph of an impact feature in a yellow painted aluminum scuff plate from the trailing edge.

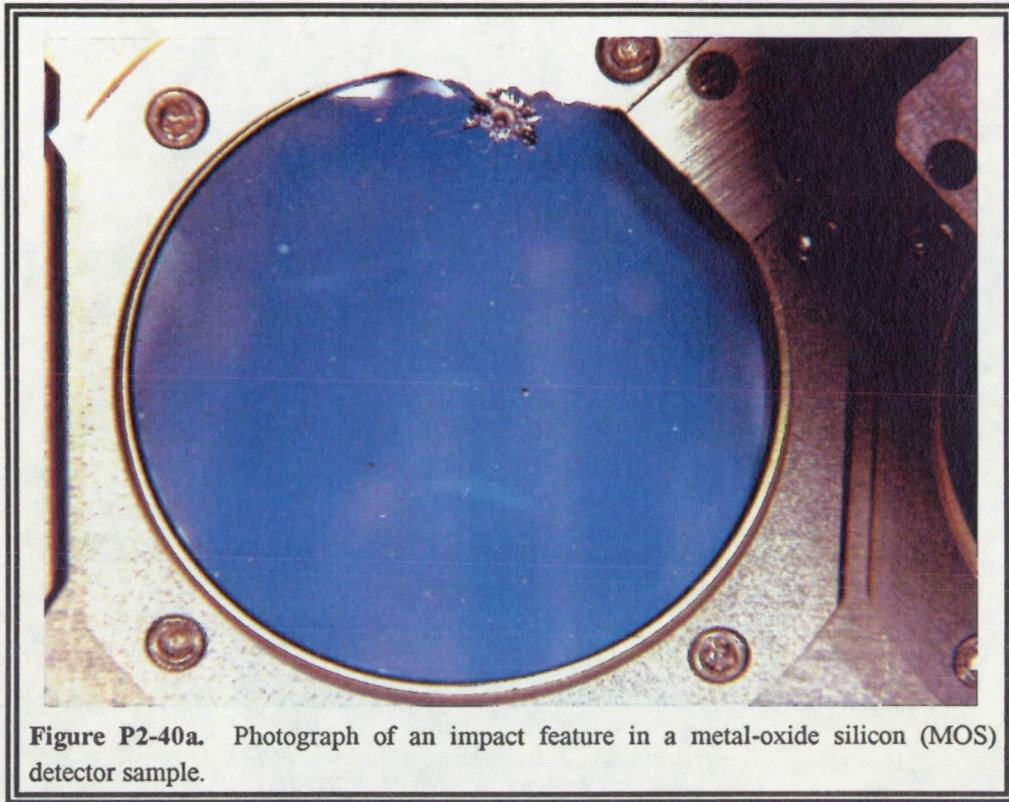
**Figure P2-40a.** Photograph of an impact feature in a metal-oxide silicon (MOS) detector sample.

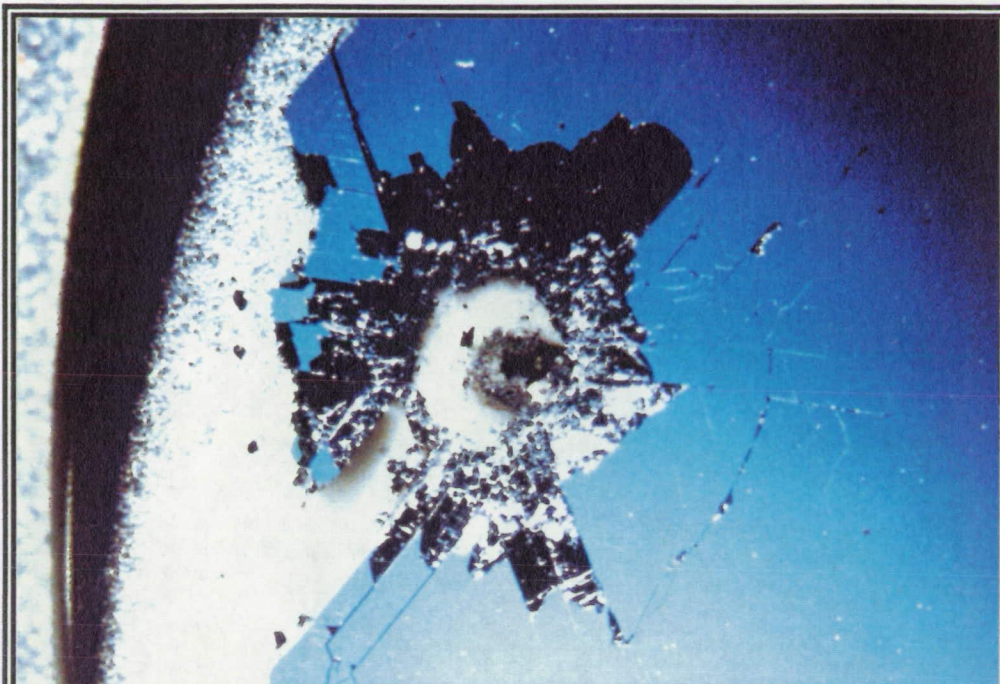
**Figure P2-40b.** Photograph of a higher magnification view of Figure P2-40a.

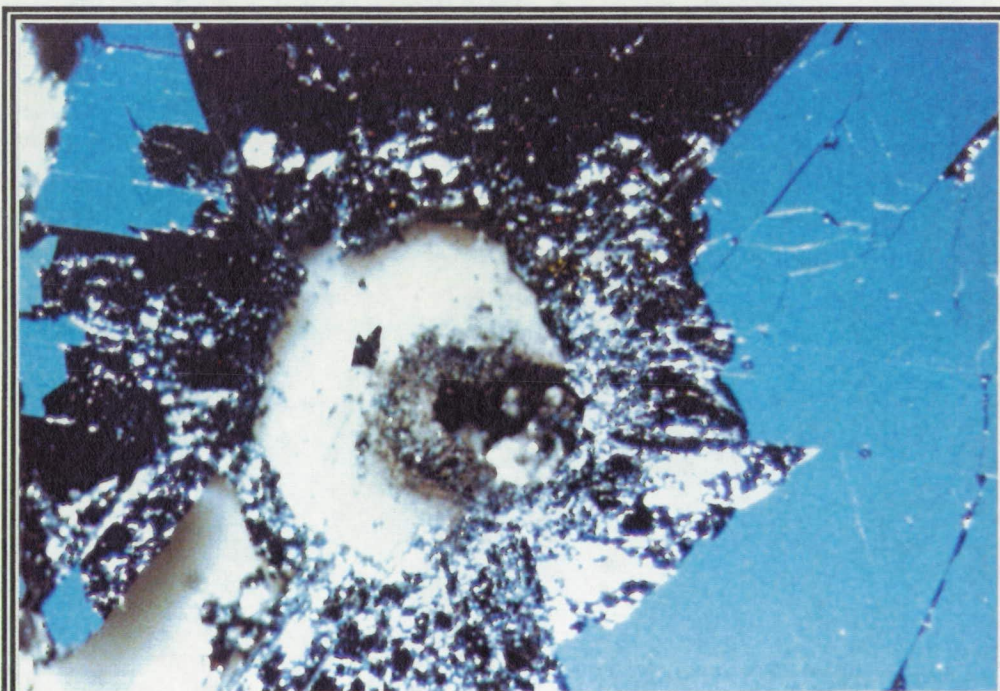
**Figure P2-40c.** Photograph of a higher magnification view of Figure P2-40b.

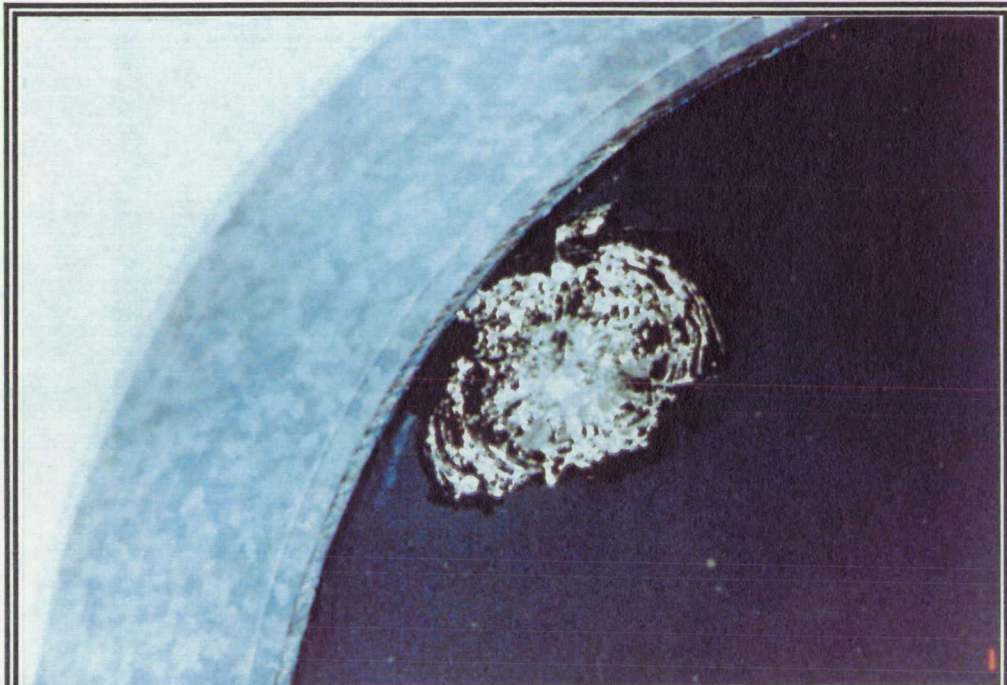
**Figure P2-41.** Photograph of an impact feature in an infrared (IR) multi-layer filter material on top of a germanium substrate.

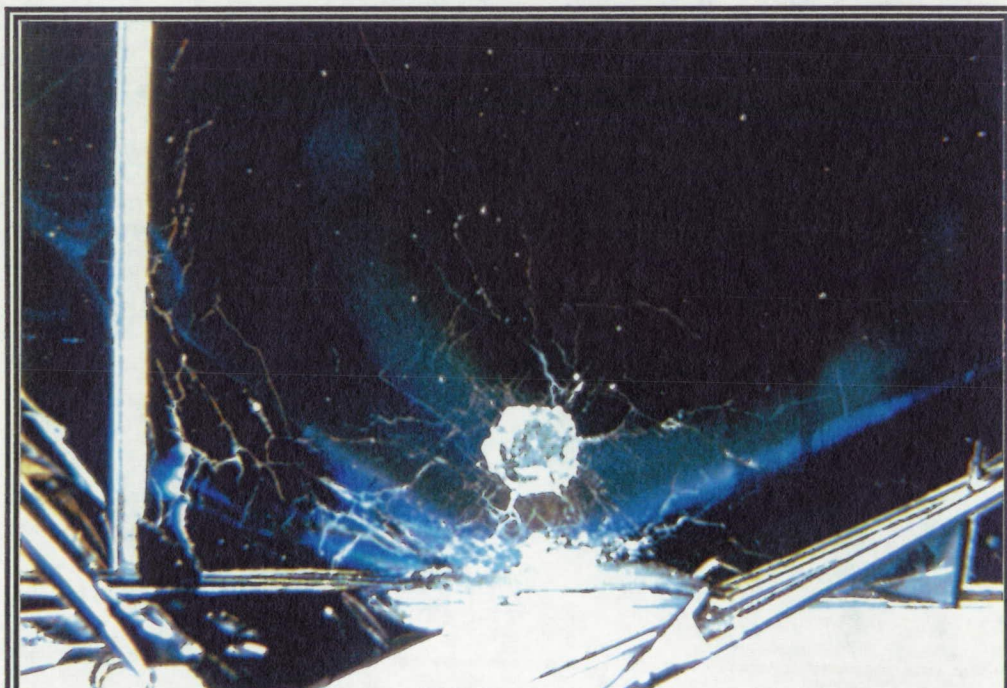
**Figure P2-42.** Photograph of an impact feature in a germanium substrate from experiment A0187-2.

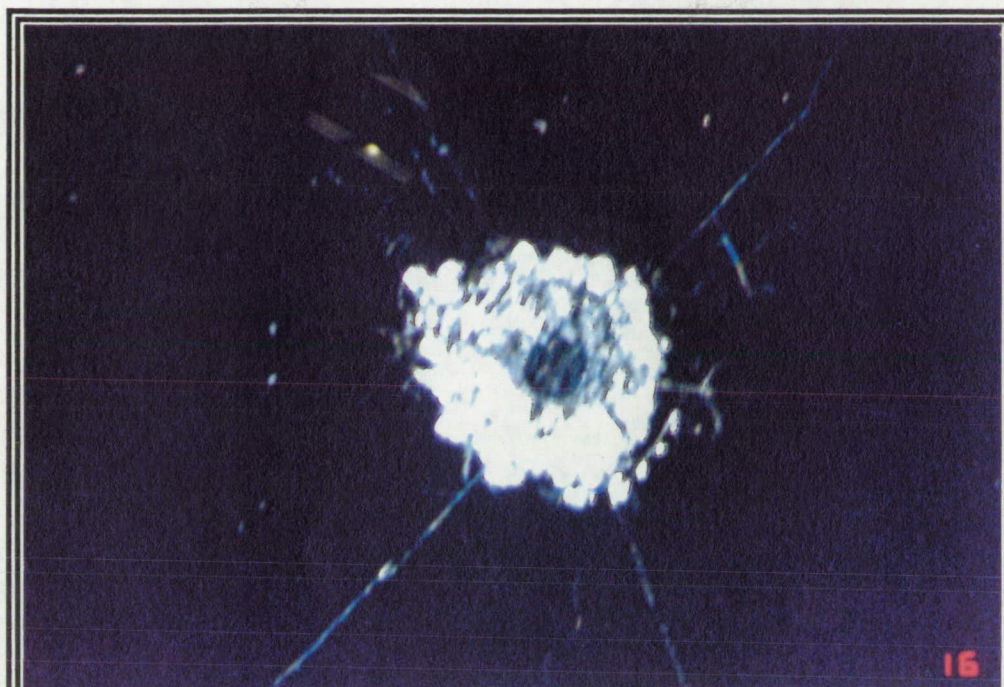
Figure P2-43. Photograph of an impact feature in a germanium substrate from experiment A0187-2.

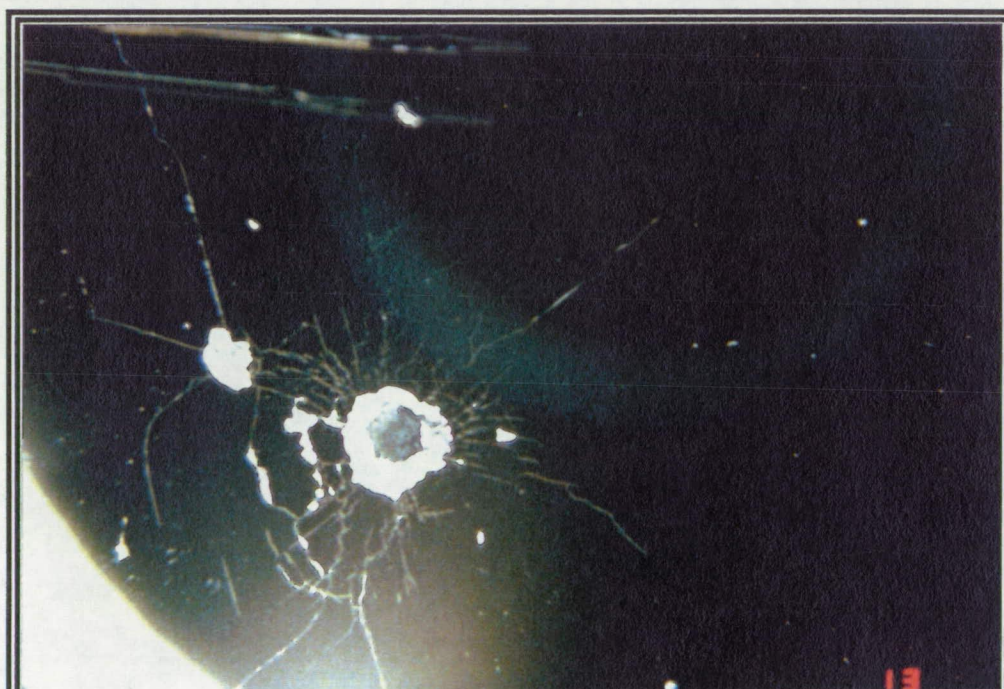
Figure P2-44. Photograph of an impact feature in a germanium substrate from experiment A0187-2.

connected to another smaller impact feature to the left causing additional damage from these two events.

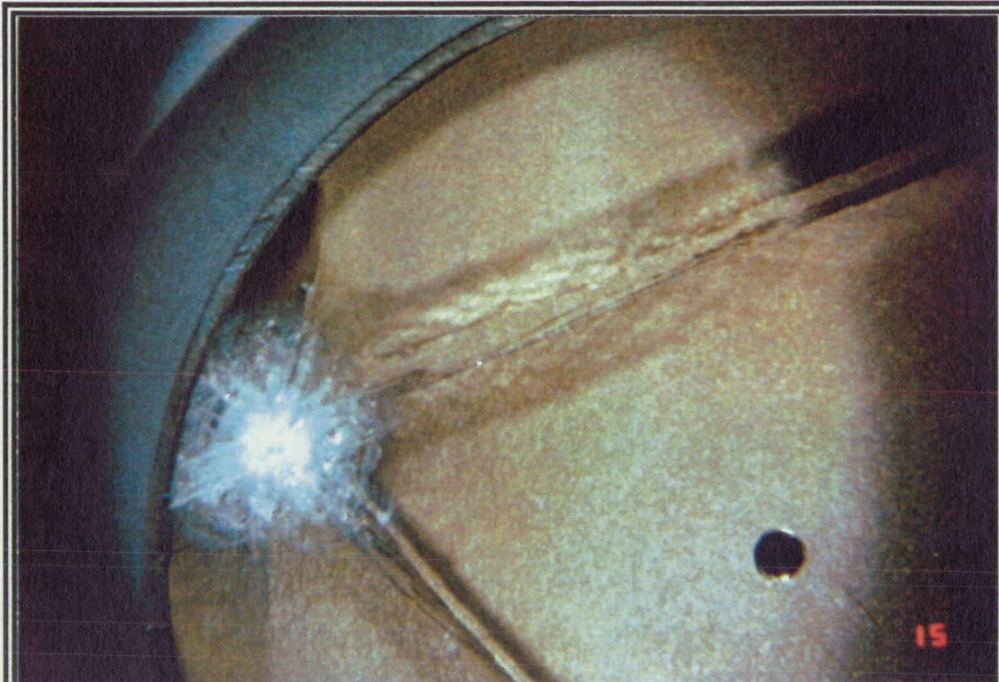
**Figure P2-45.** Photograph of an impact feature in a brittle substrate (glass sample).

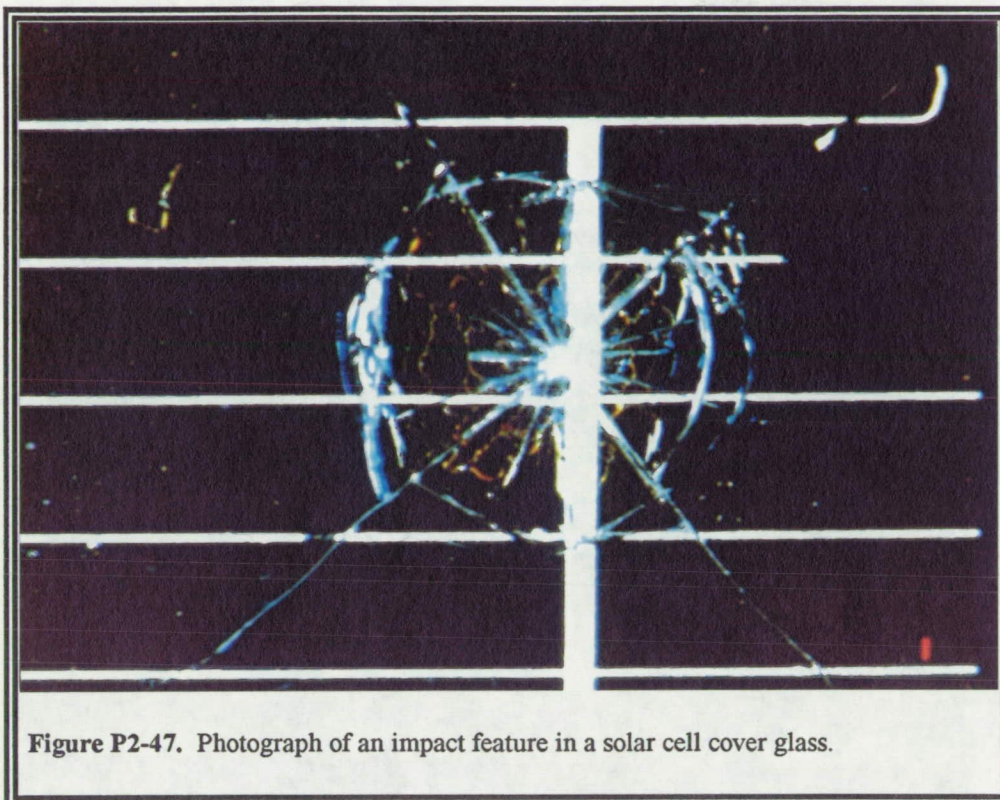
**Figure P2-47.** Photograph of an impact feature in a solar cell cover glass.

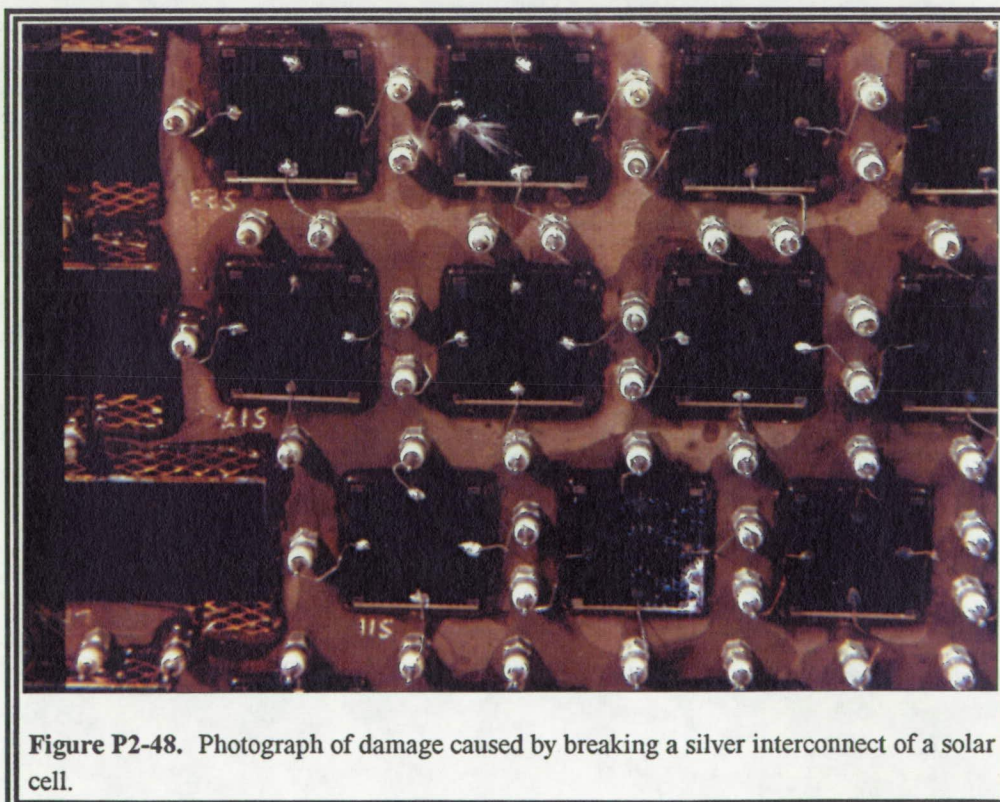
**Figure P2-48.** Photograph of damage caused by breaking a silver interconnect of a solar cell.

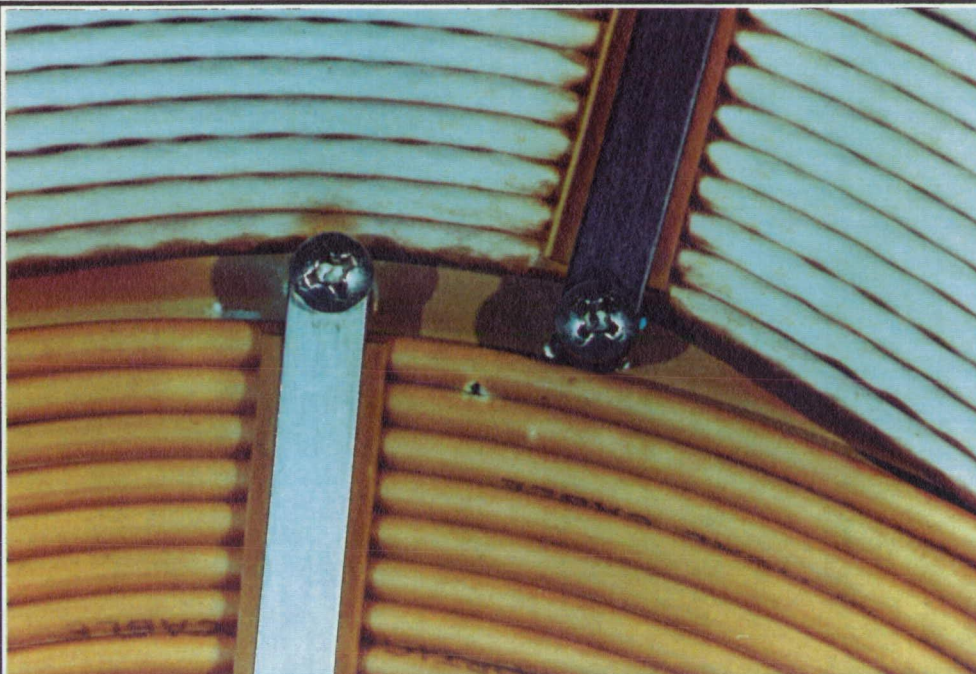
**Figure P2-49.** Photograph of an impact feature in a fiber optic bundle.

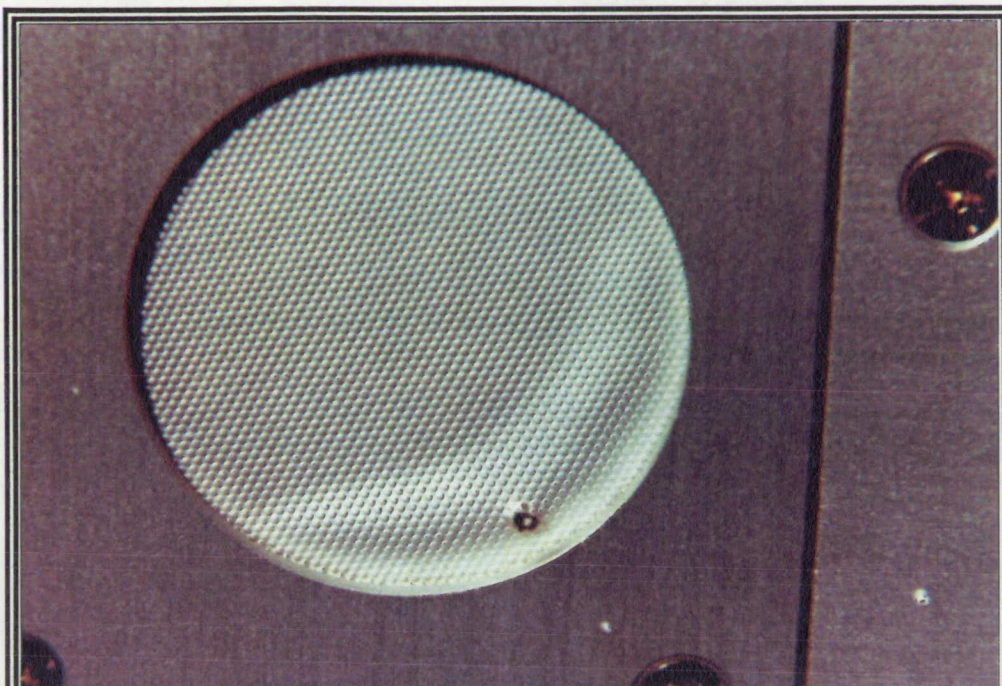
**Figure P2-51.** Photograph of an impact feature in beta cloth.

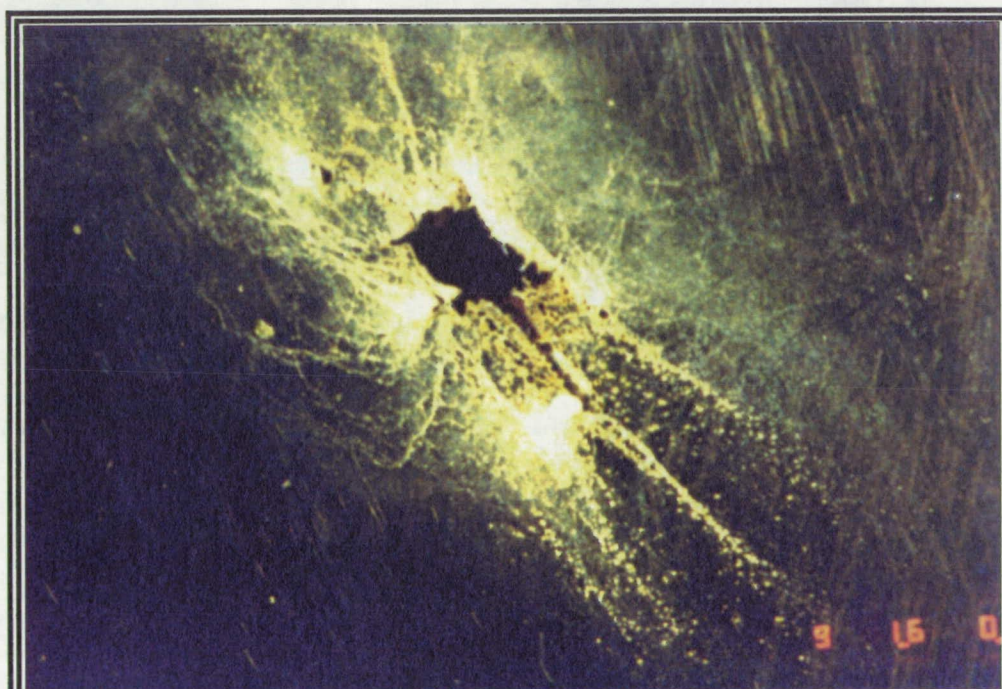
**Figure P2-52.** Photograph of an impact penetration through a fiberglass material.

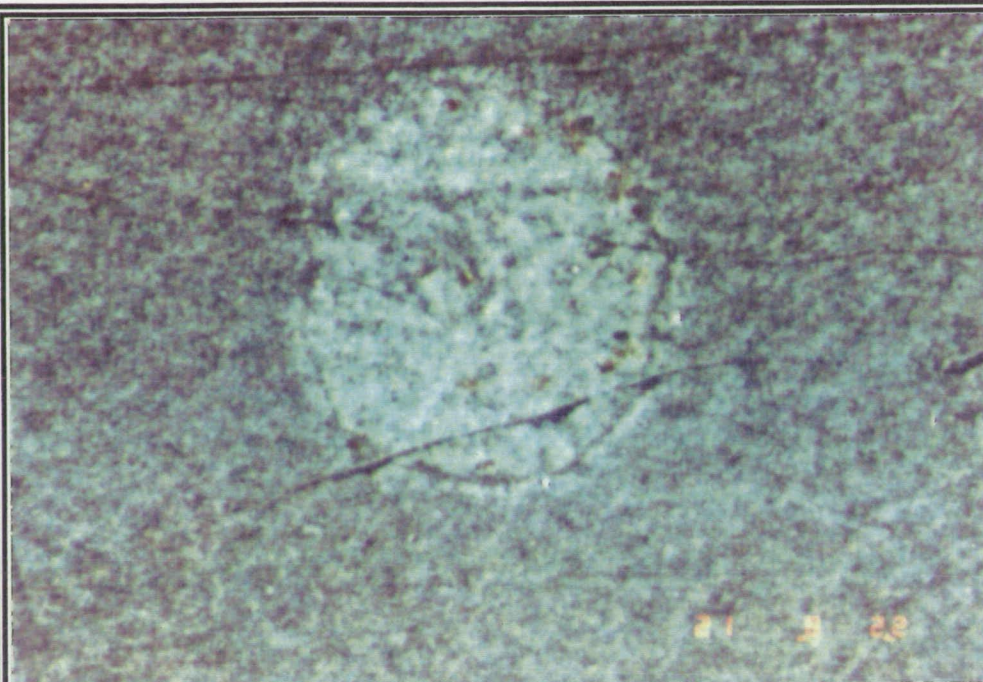
**Figure P2-53.** Photograph of a urine spot contamination feature.

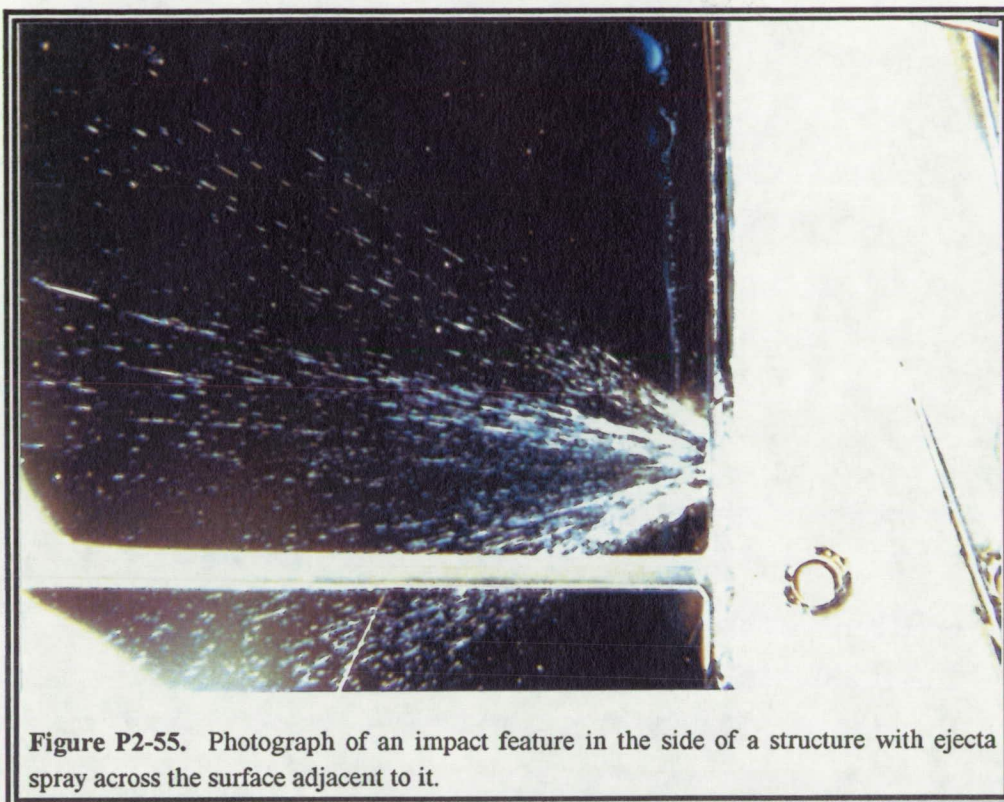
**Figure P2-55.** Photograph of an impact feature in the side of a structure with ejecta spray across the surface adjacent to it.

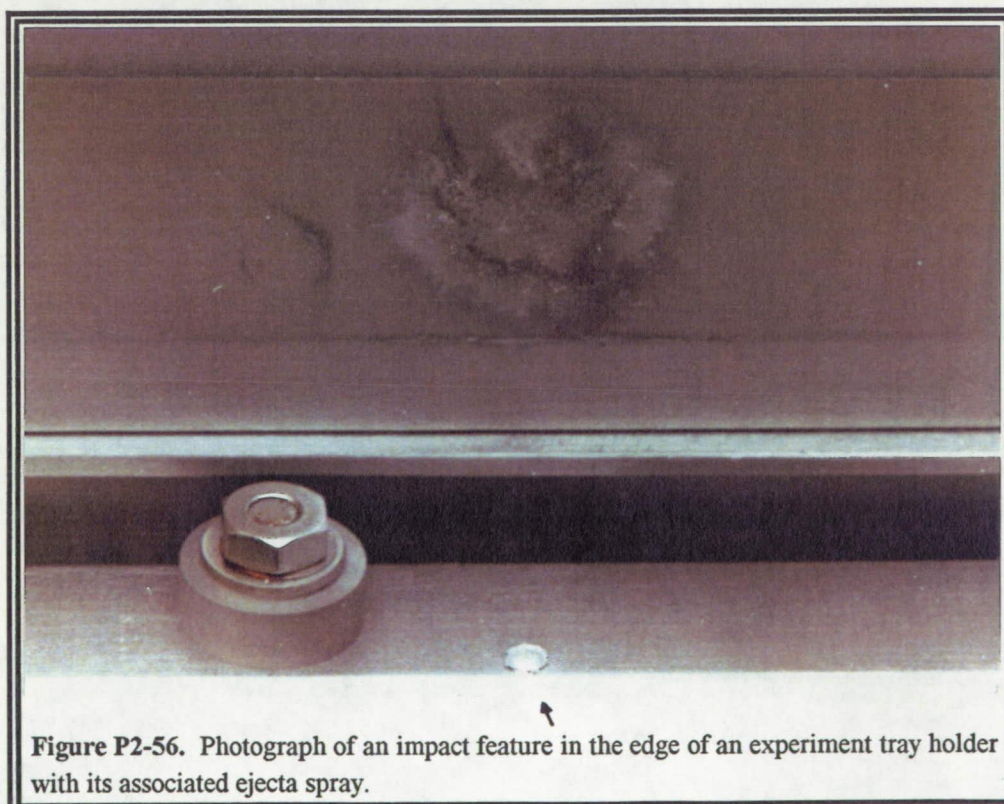
**Figure P2-56.** Photograph of an impact feature in the edge of an experiment tray holder with its associated ejecta spray.
